Debris/Ice/TPS Assessment And Photographic Analysis For Shuttle Mission STS-39

Gregory N. Katnik
NASA/Kennedy Space Center

June 1991

DEBRIS/ICE/TPS ASSESSMENT
AND
PHOTOGRAPHIC ANALYSIS
OF
SHUTTLE MISSION STS-39

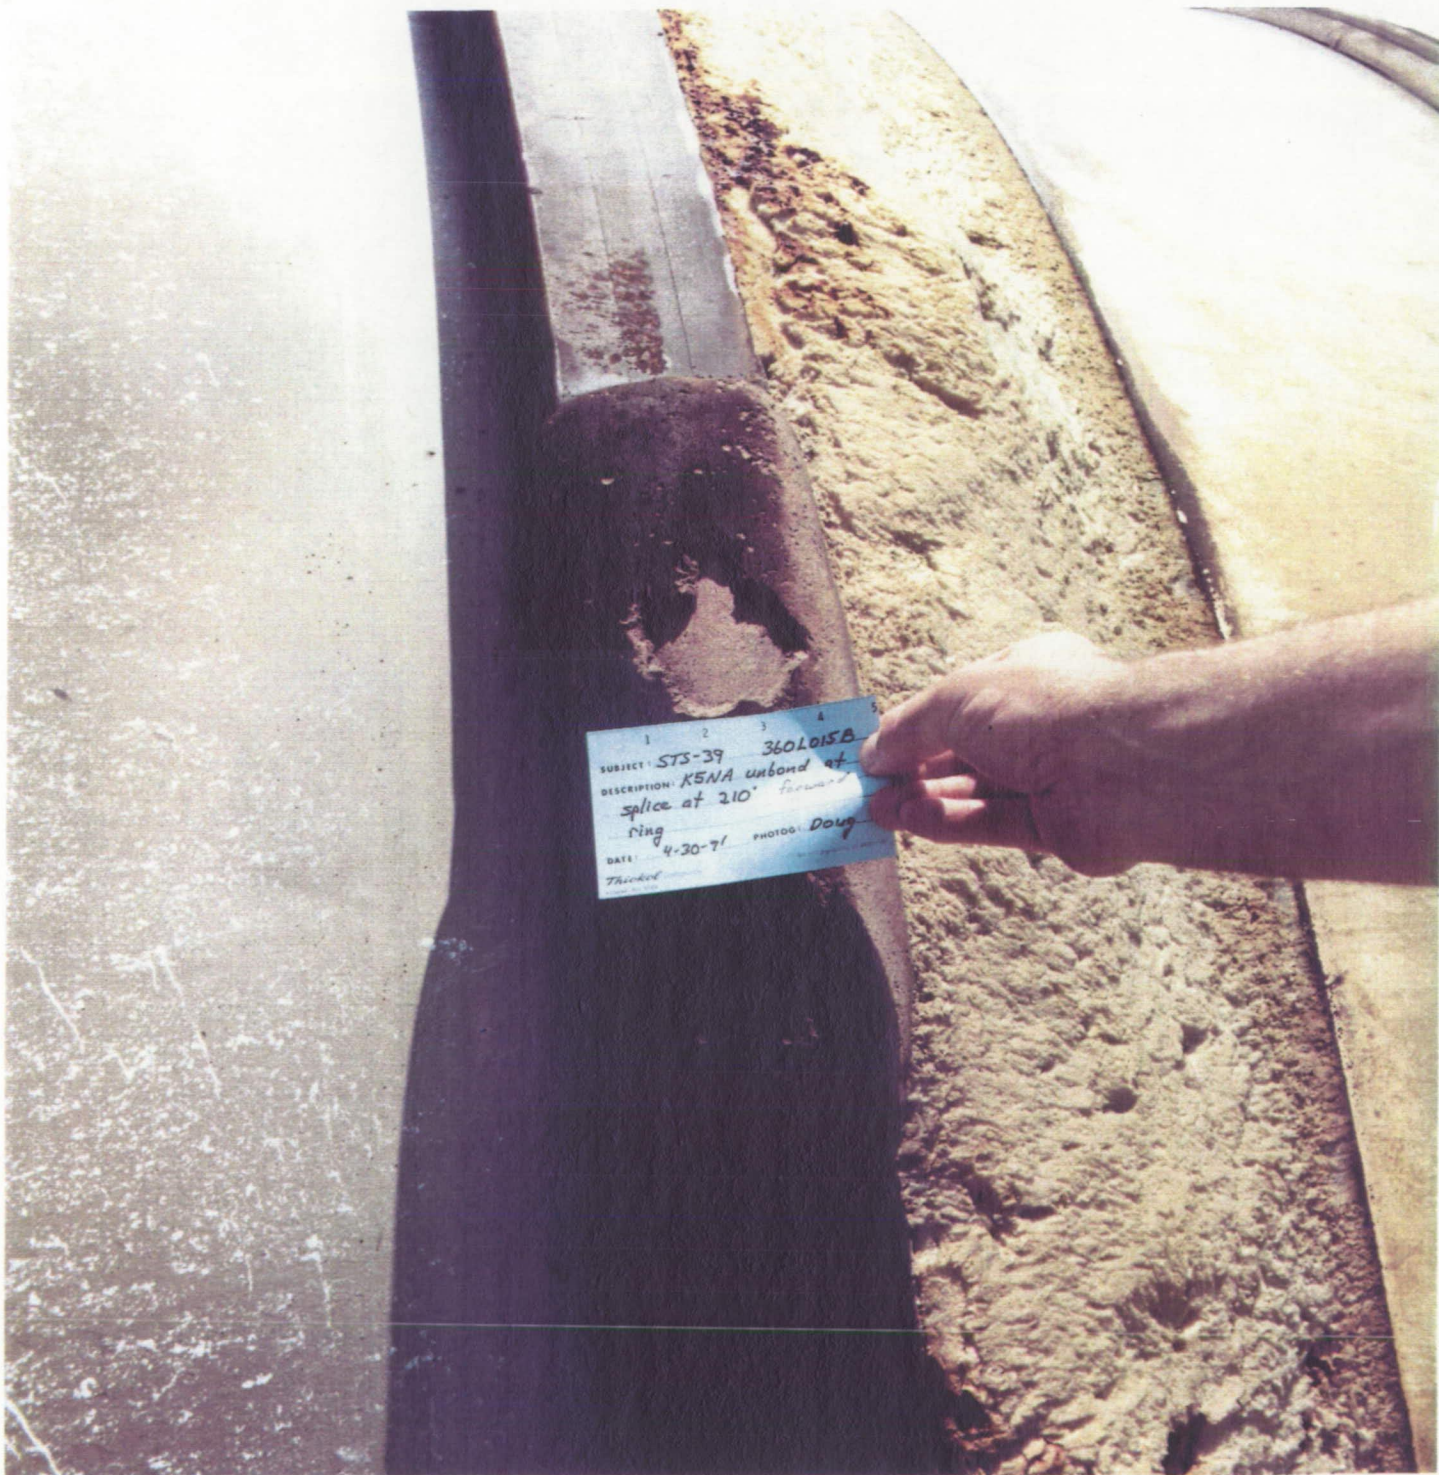
K5NA was missing from the RH SRB aft booster stiffener ring splice plates (aft ring at 330 degrees, forward ring at 210 degrees). The remaining material was not charred and loss of the K5NA occurred at water impact. Post flight assessment showed failure of the K5NA was caused by an unbond between the first and second layers and may be indicative of improper K5NA application (use of the "pancake" method instead of a homogeneous hand-pack). A suspect PR was taken against similar K5NA closeouts on STS-40, 43, and 48. A potential debris hazard exists if the K5NA is lost at liftoff or during ascent.

K5NA was missing from the RH aft booster stiffener ring splice plates (aft ring at 330 degrees, forward ring at 210 degrees). The substrate was not charred and loss of the material occurred at water impact.

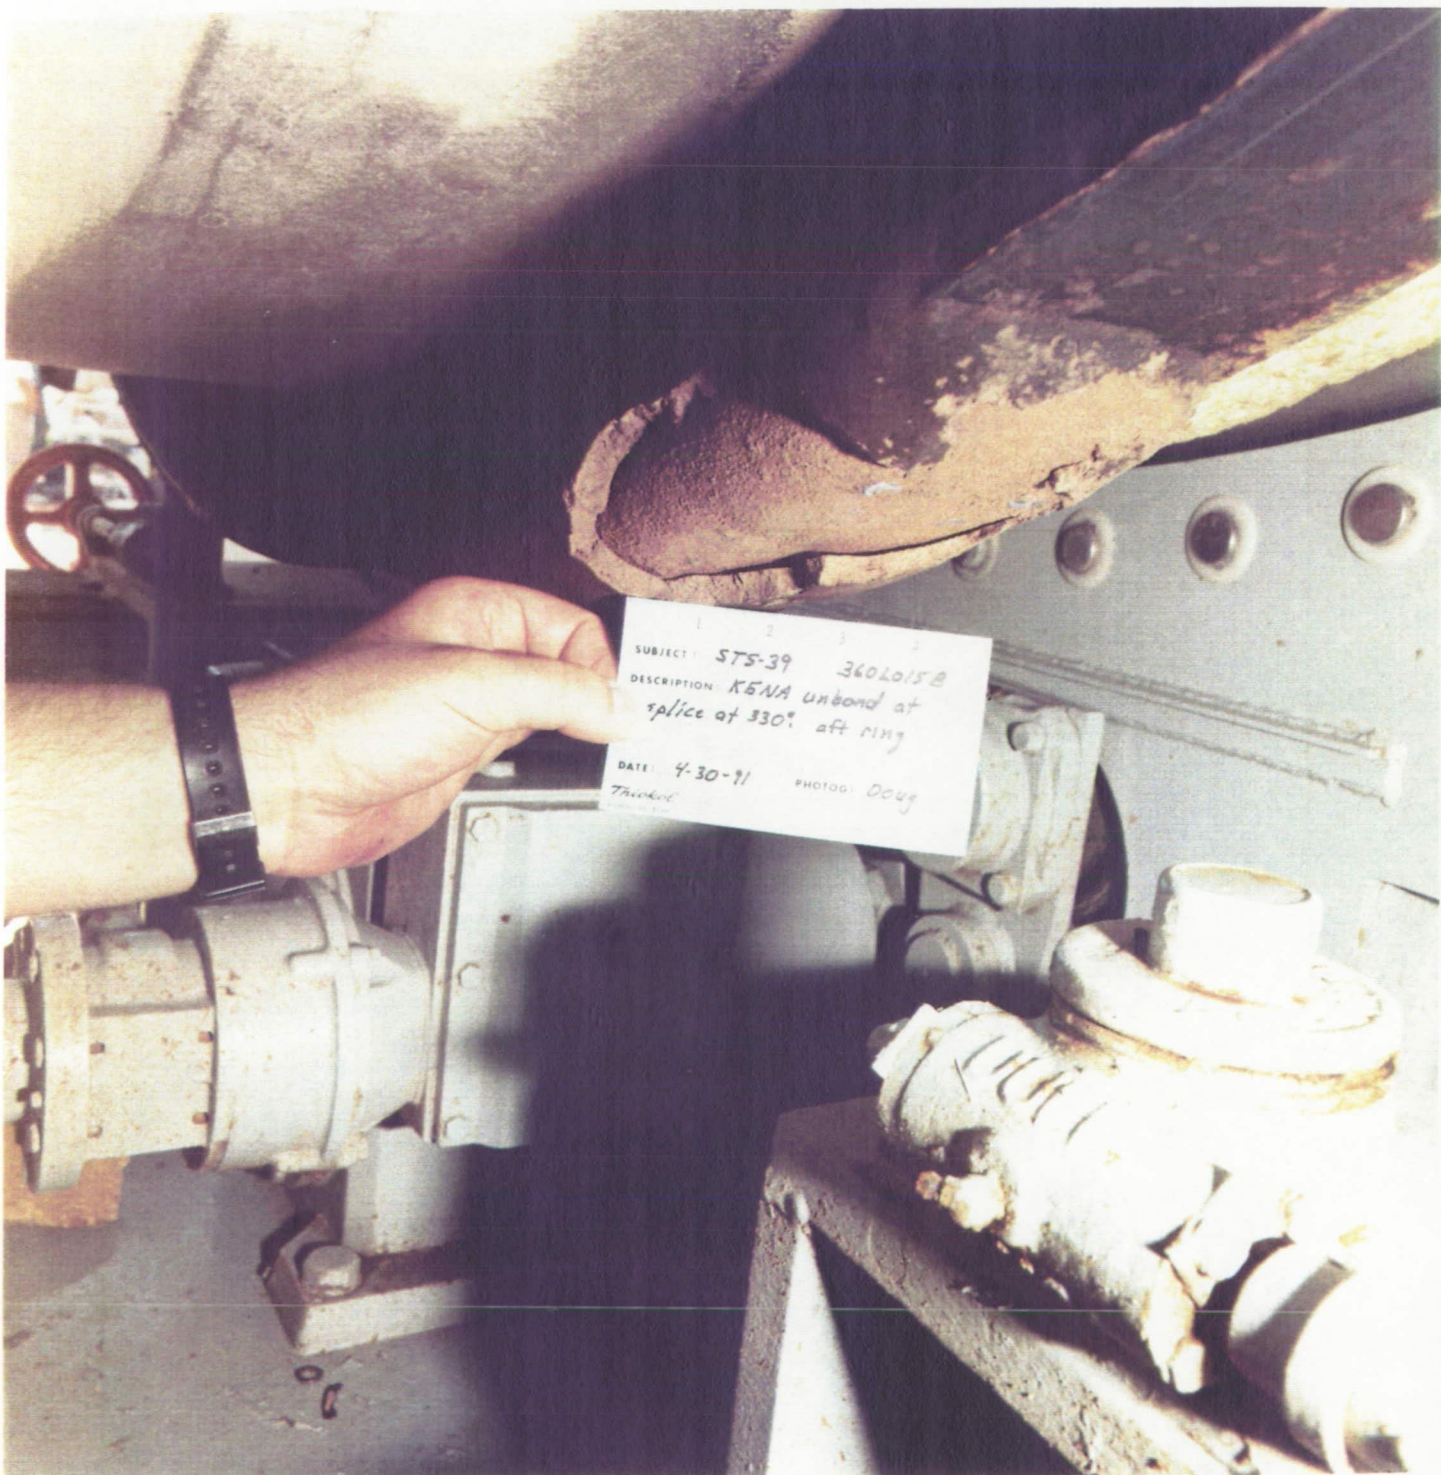
Post flight assessment showed failure of the K5NA was caused by an unbond at the substrate. Loss of this closeout at T-0 or during ascent could be a potential debris hazard.

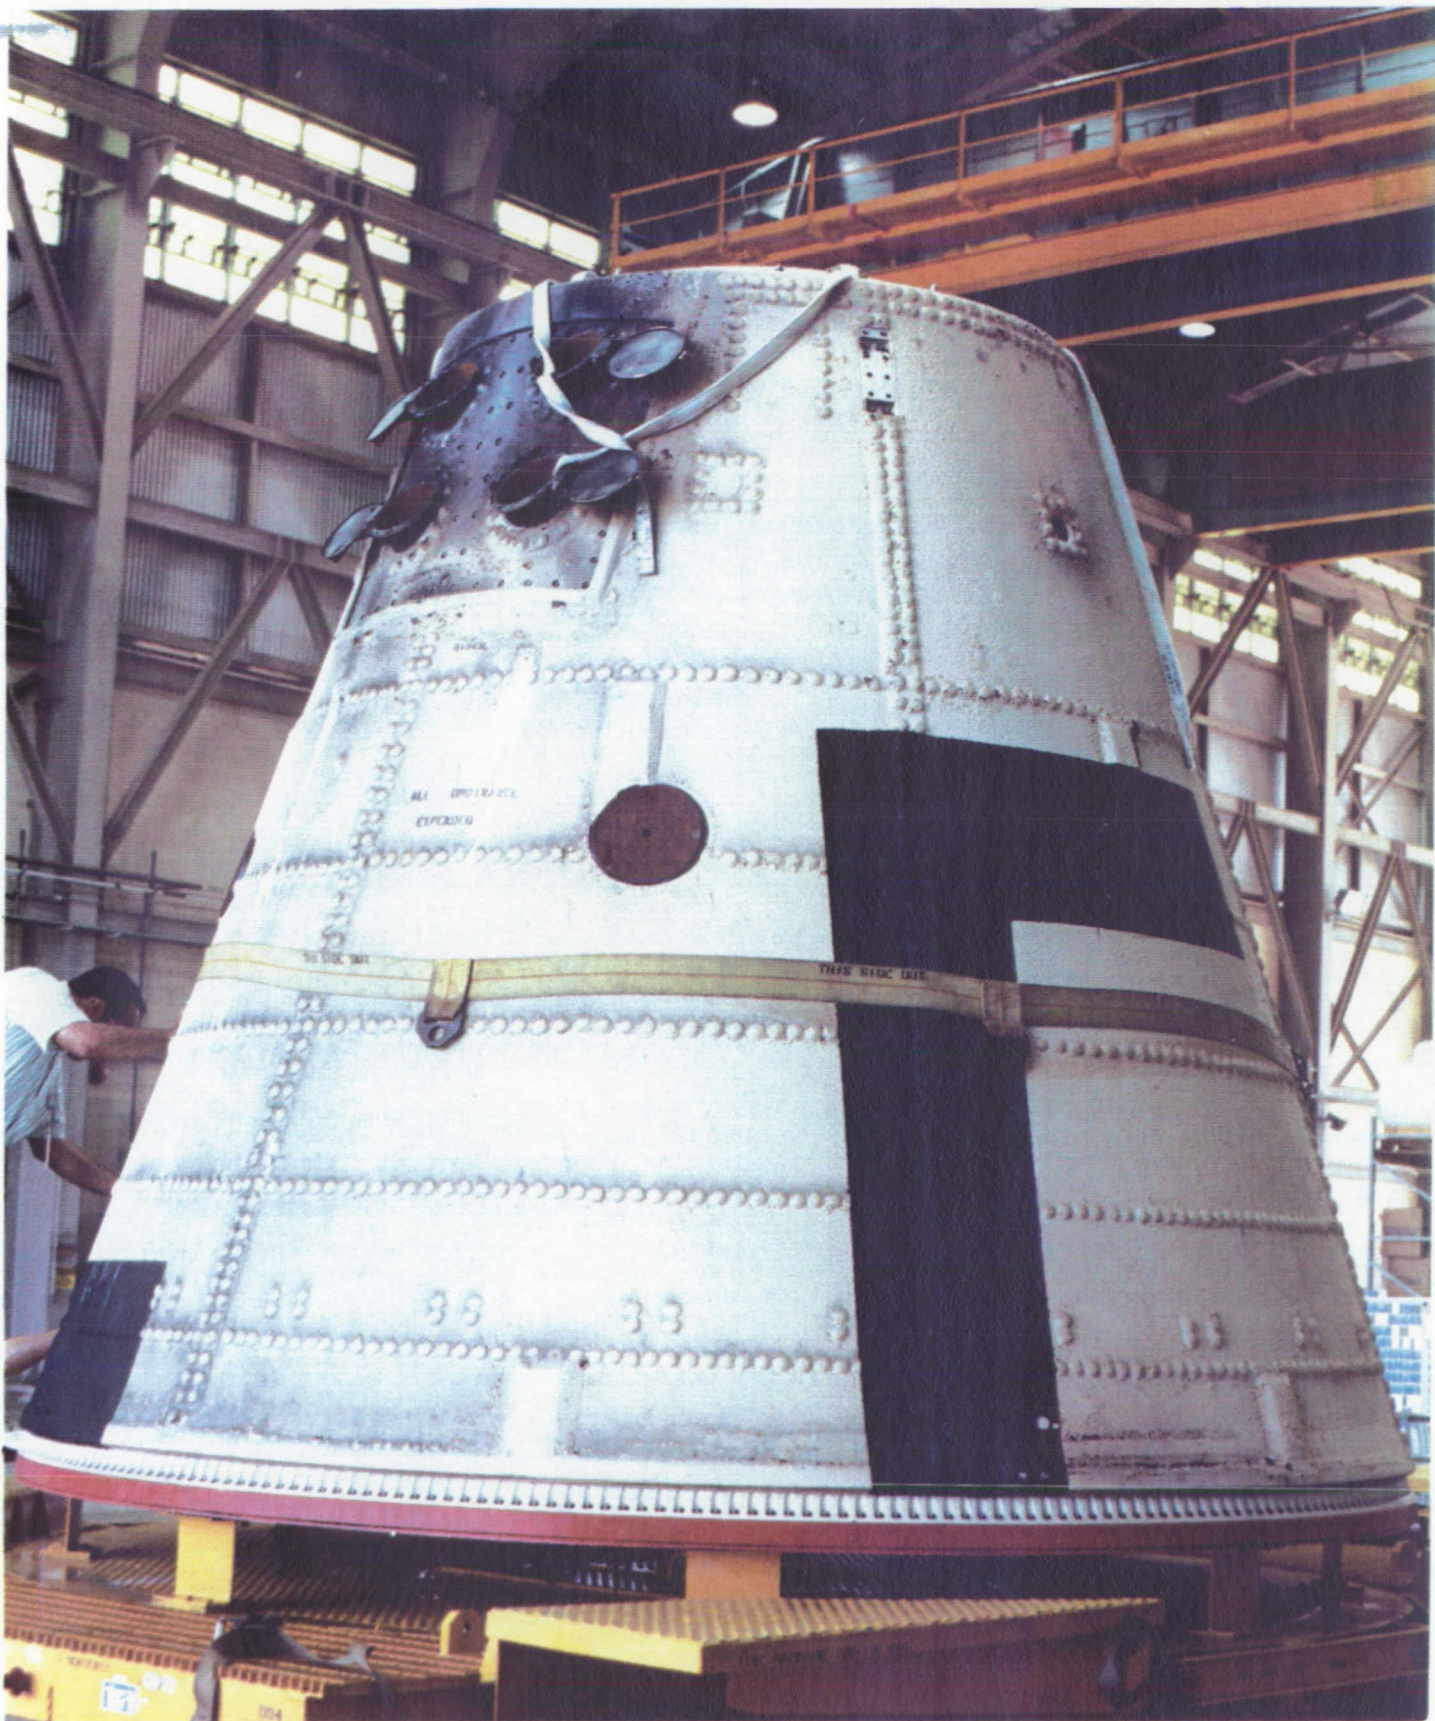
Post flight condition of the LH frustum. There were 22 MSA-2 debonds over fasteners, but no missing TPS.

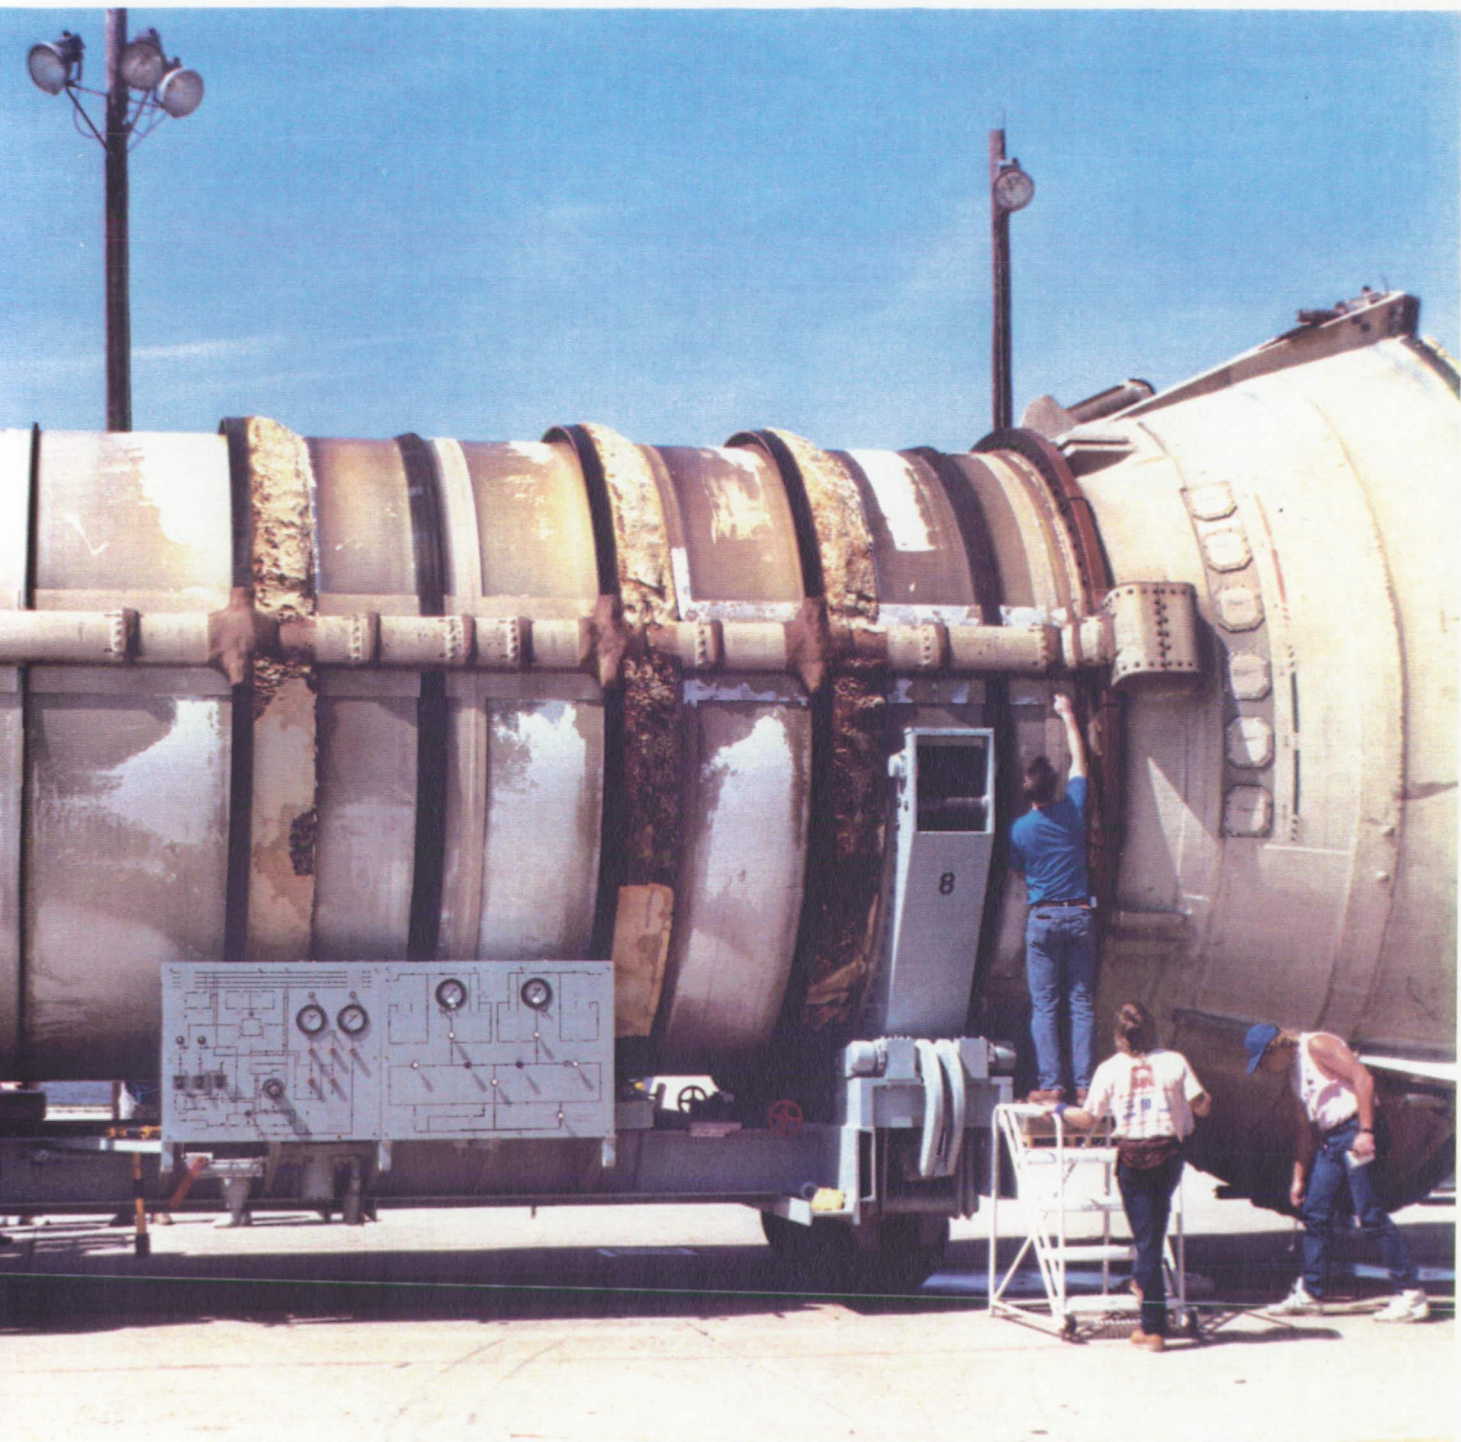
Post flight condition of the LH aft booster. All three stiffener rings were damaged by water impact.

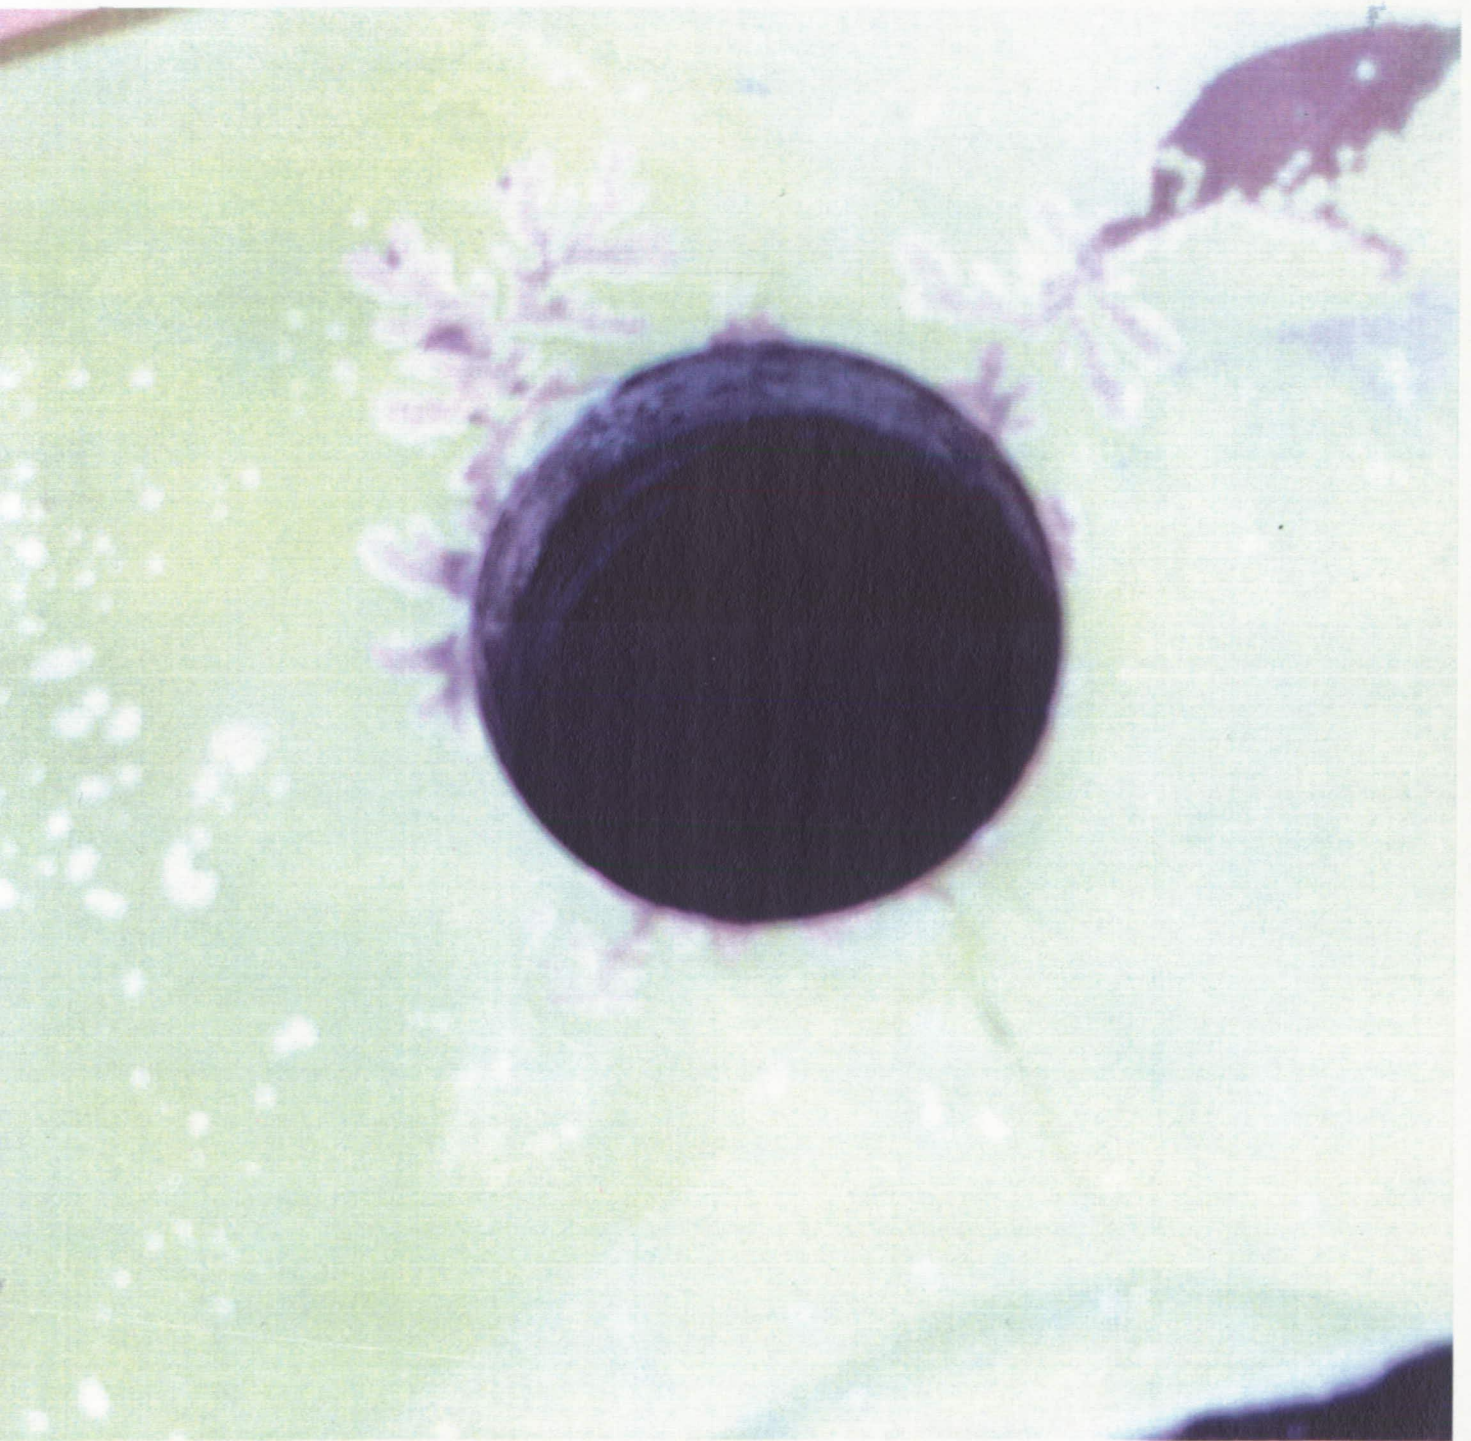
Debris Containment System (DCS) plungers were properly seated except for HDP #7, which was obstructed by frangible nut halves. None of the EPON shim material on the LH aft skirt was missing prior to water impact.

Holddown post #7 Debris Containment System (DCS) plunger was obstructed by frangible nut halves. Five ordnance fragments had fallen from the DCS/stud hole shortly after liftoff.

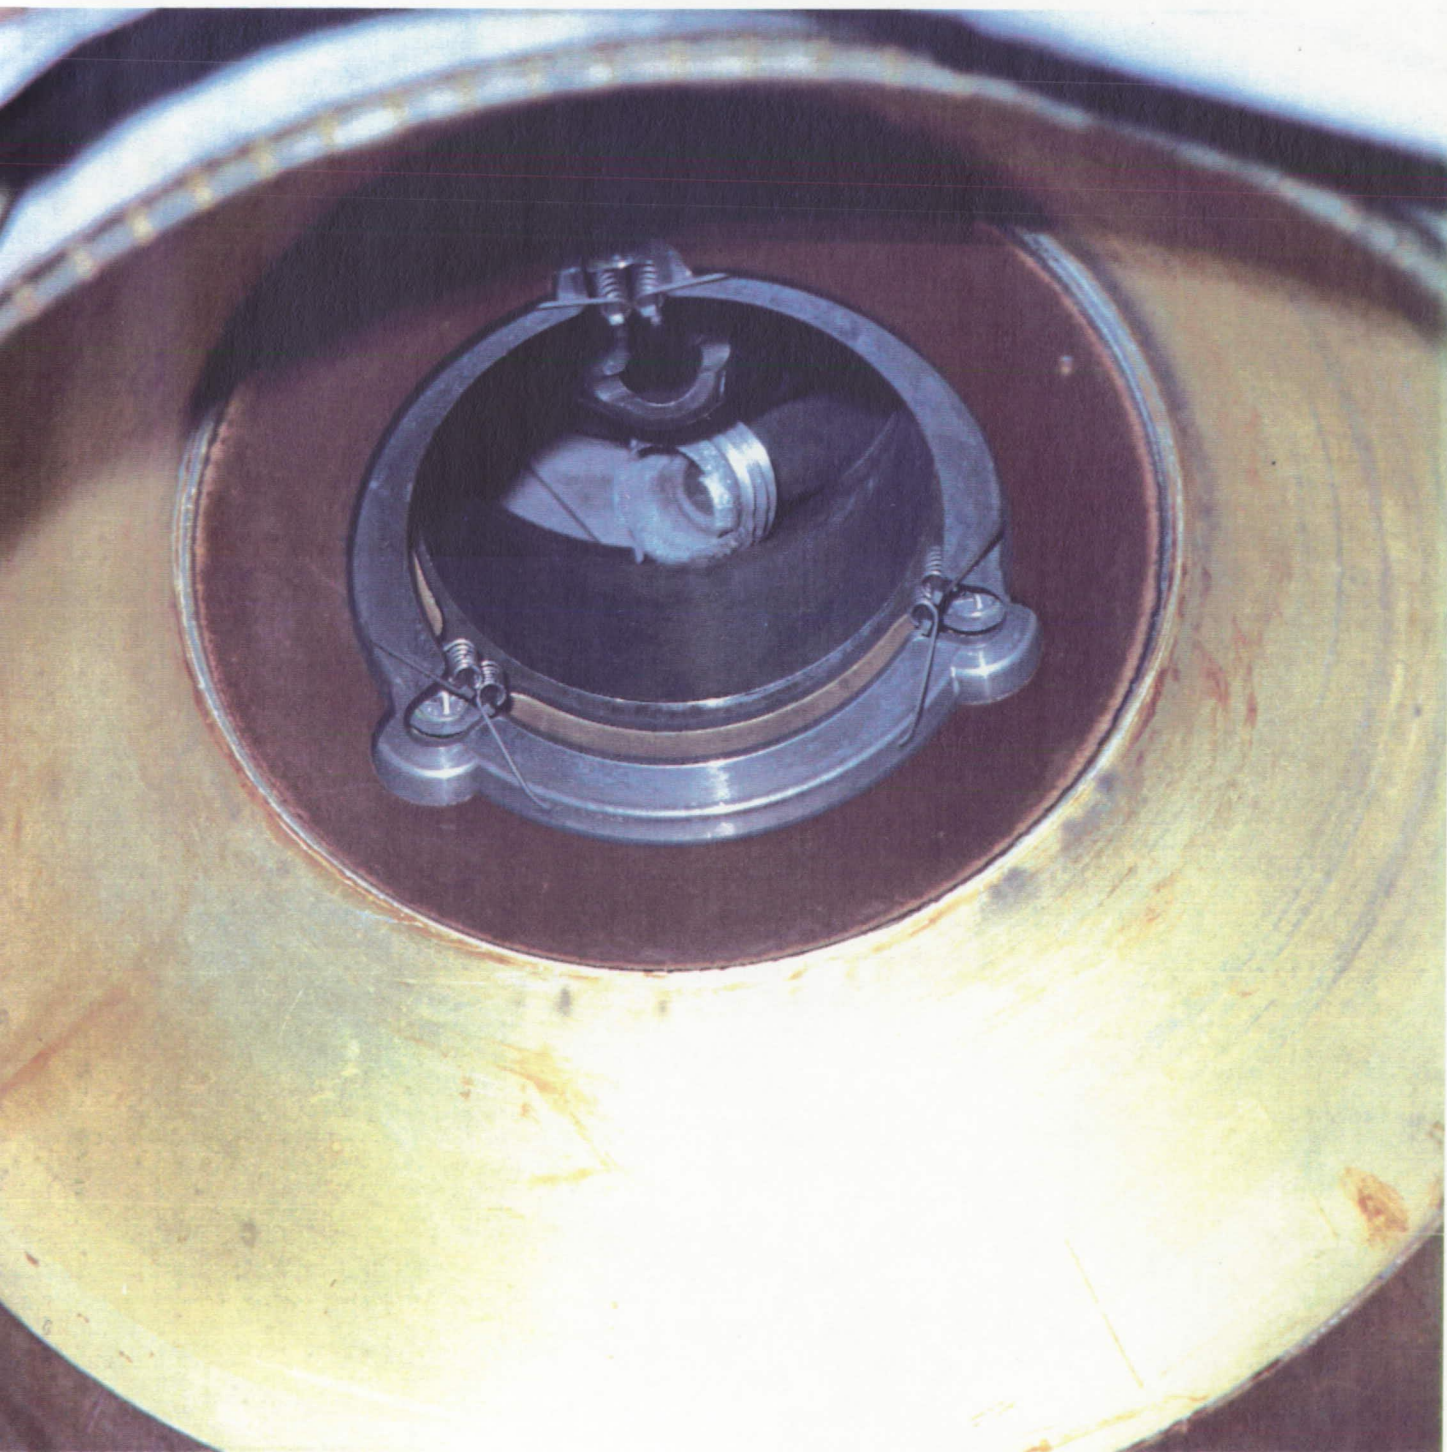
EO-3 debris plunger was obstructed by an NSI cartridge fragment

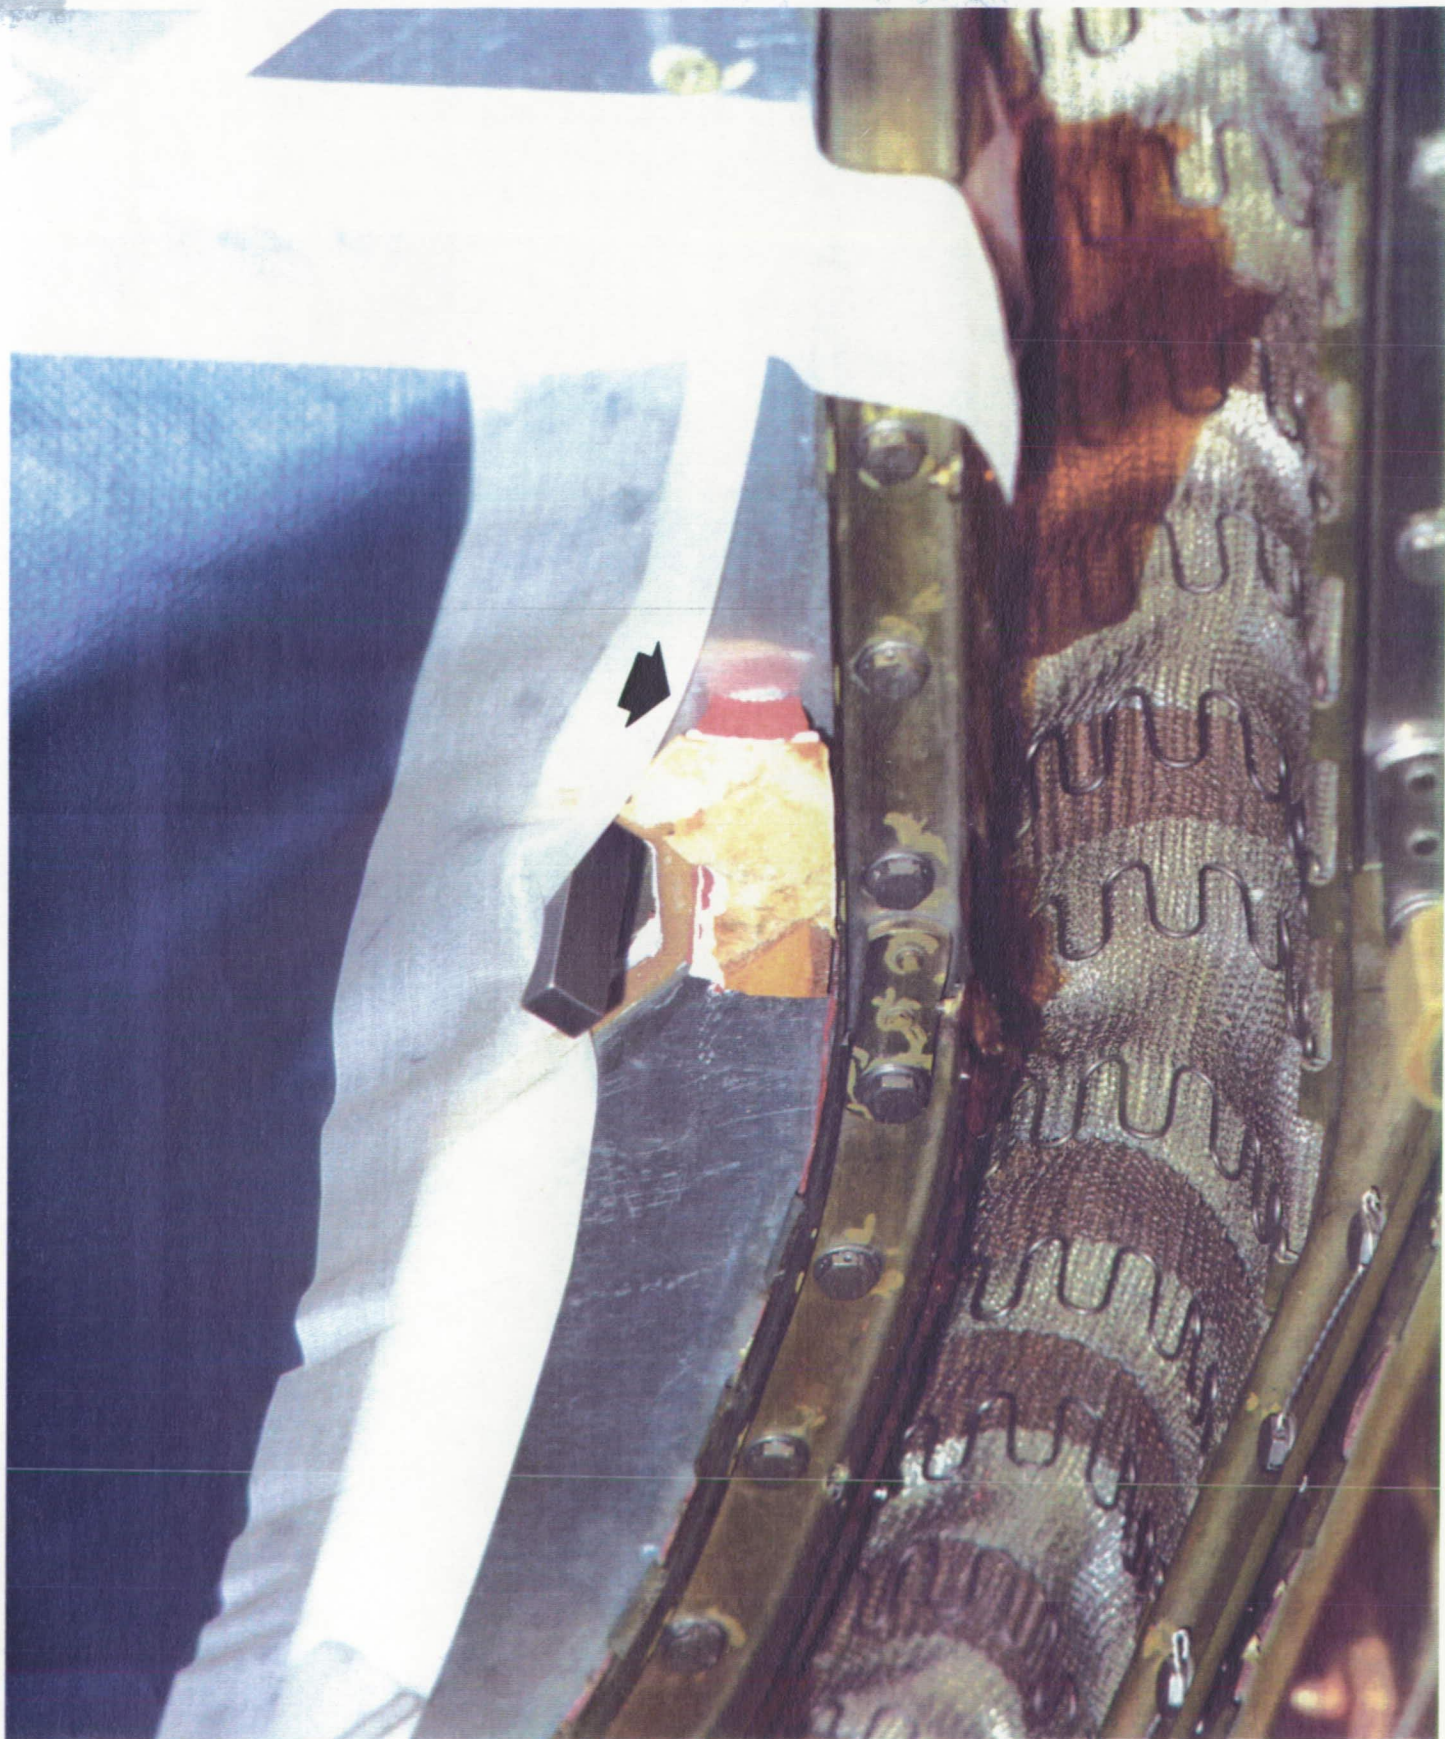
2-inch piece of umbilical purge seal, which should have remained attached to the External Tank, adhered to the Orbiter side of the LH2 ET/ORB umbilical plate

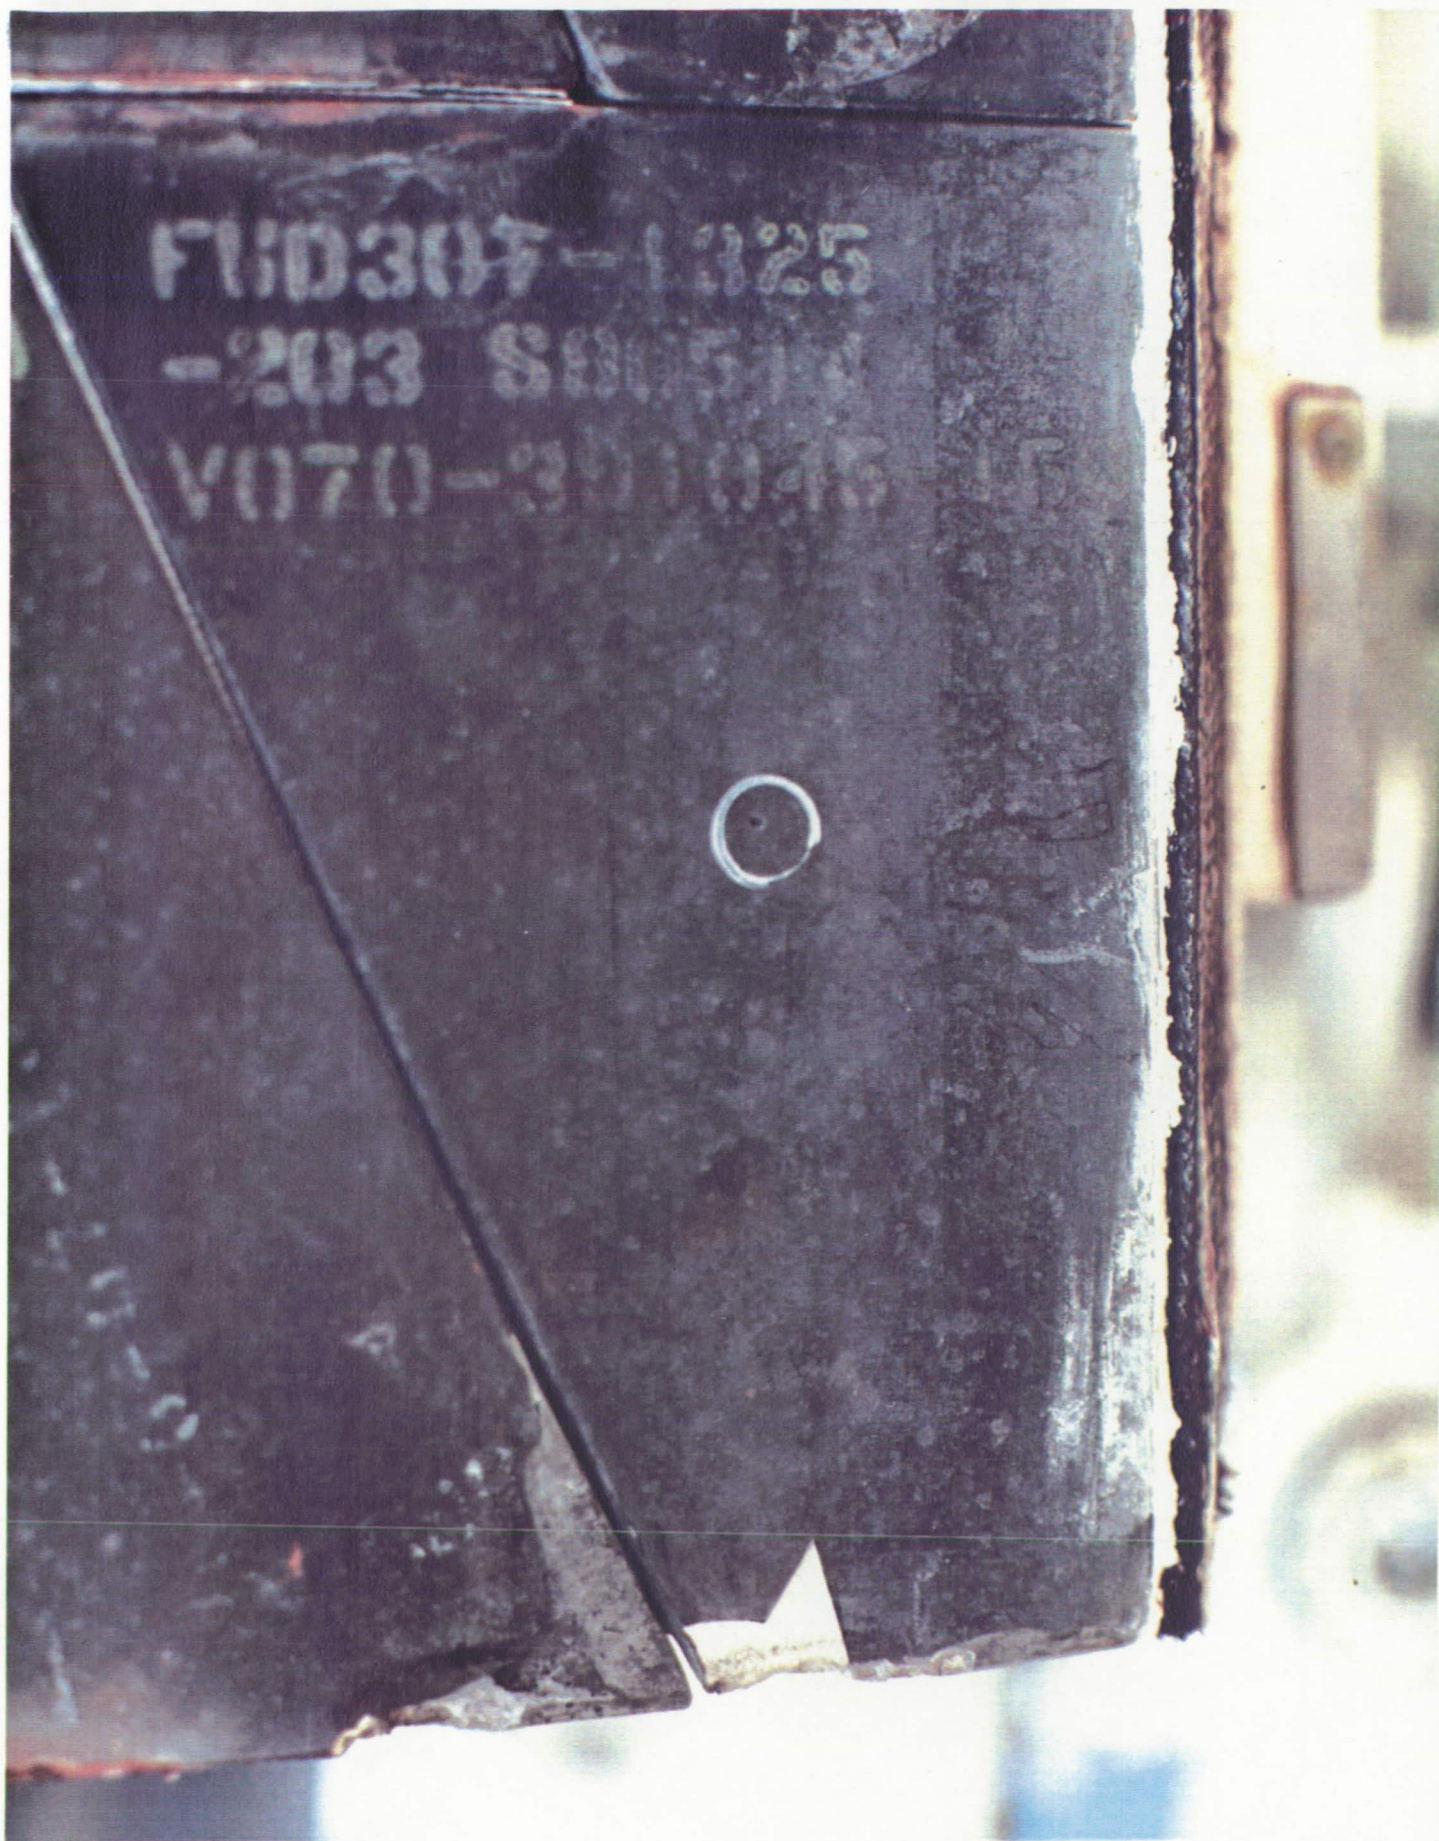
Tile damage on trailing edge of RH nose landing gear door

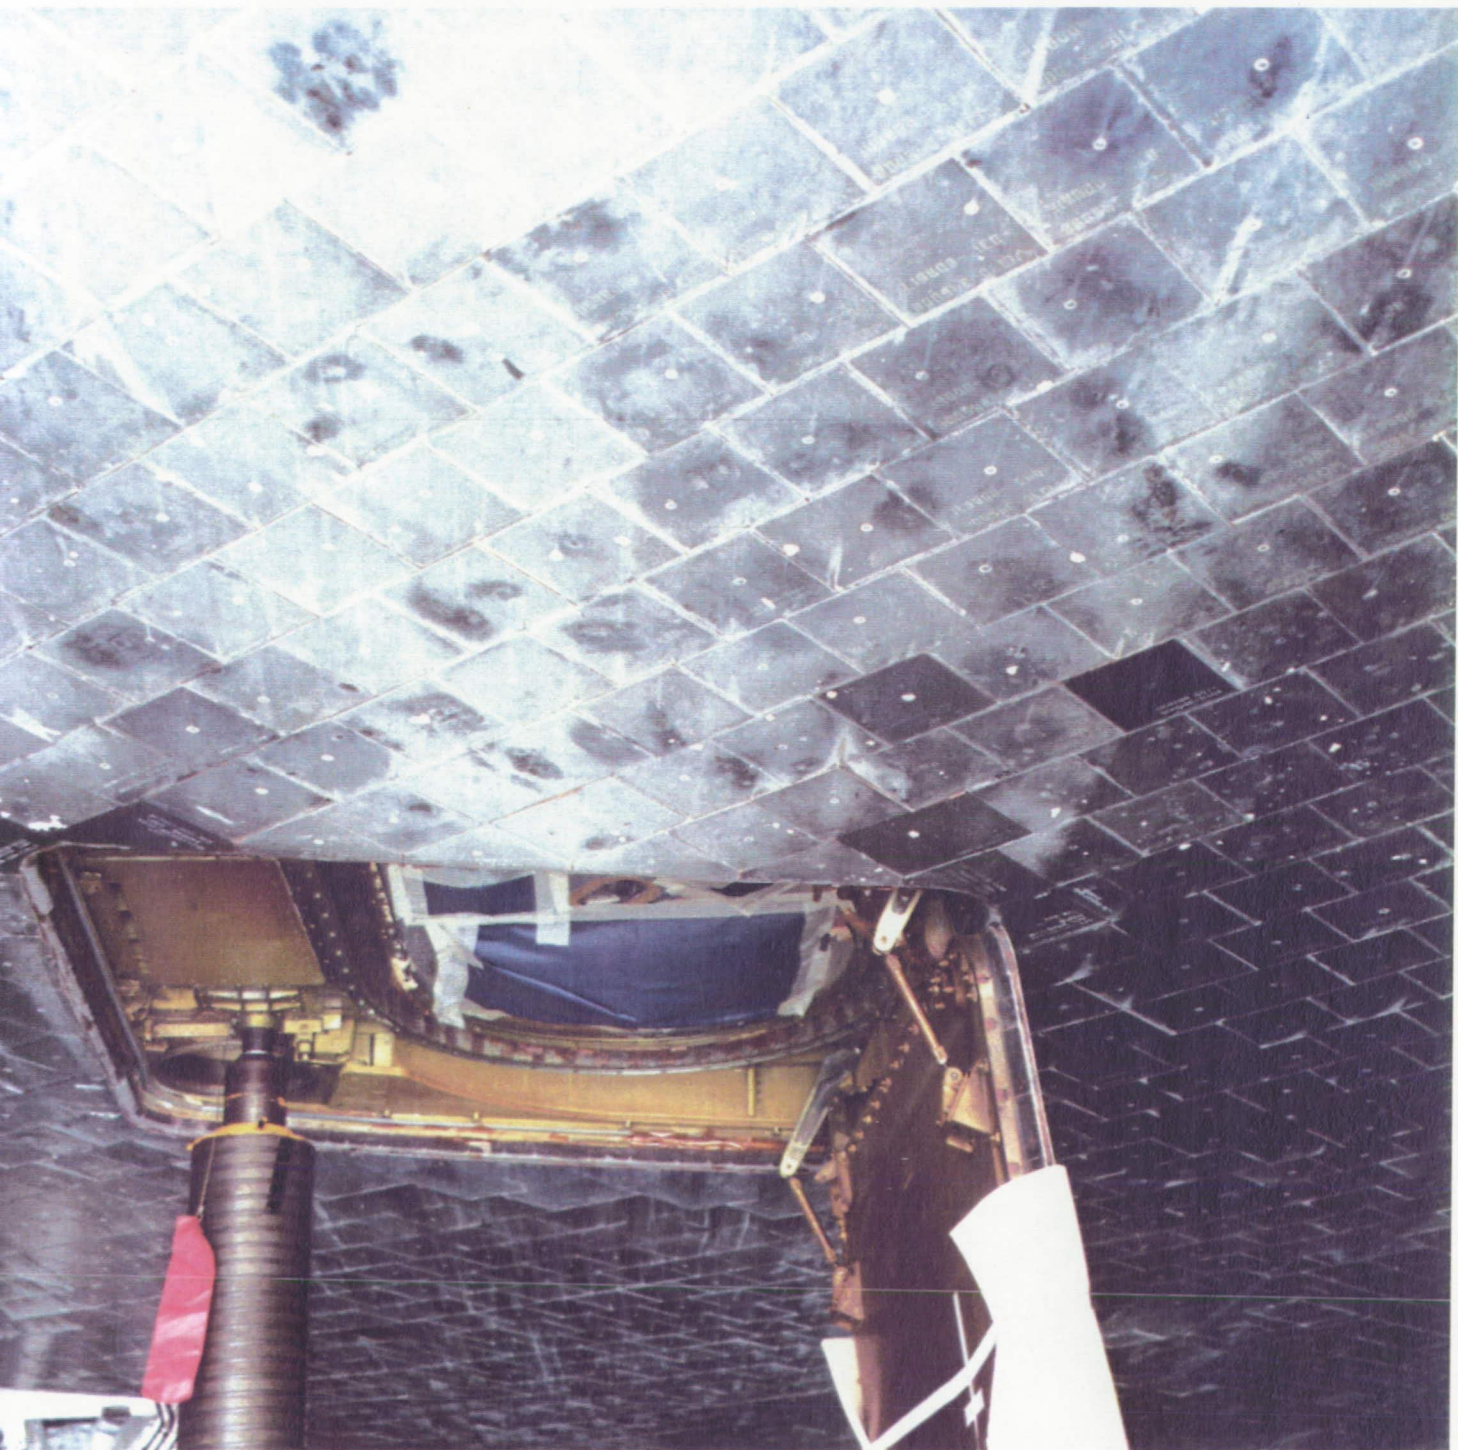
Cluster of hits on the tiles aft of the LH2 ET/ORB umbilical is typically caused by ice impacts during ascent and separation
